Industries Bouchard, Inc.

DATE June, 24 1970

SUBJECT: Modification on 1971 Mini-Sno

TM/70-01

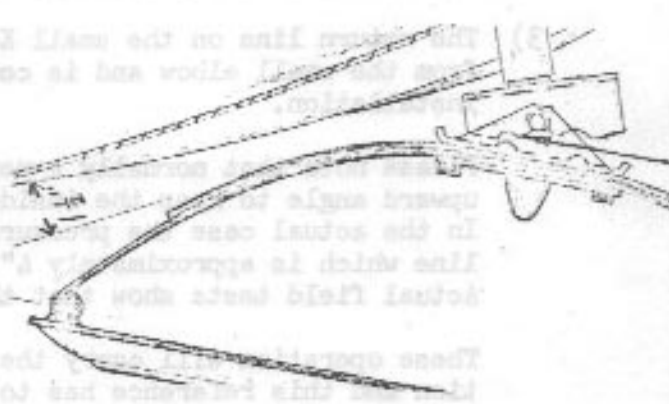
1) Skis: you will notice that the ski stops prevent the skis from lifting at the rear end.

CURE: Before installing the skis, grind the bottom portion of the ski stop so that the closest distance between the top of the spring leaf and bottom of the pan is $1\frac{1}{2}$ ". The amount of grinding required may vary between units; this is why we are giving the minimum distance to be maintained instead of the amount of metal to be removed from the stop.

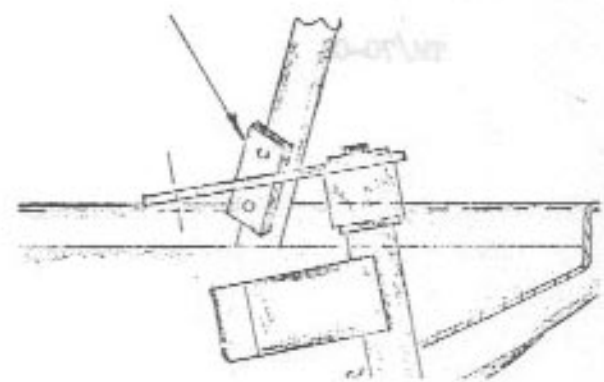
2) When the steering is turned, the handle bar touch the motor cover. The reason for this is that the front brace is located slightly to far ahead allowing the steering arms to turn at too wide an angle.

CURE Insertion of rubber stops on both sides: before assembling skis, remove the steering arms from ski legs to allow room to reach the vertical portion of the front brace. This easily done by slackening the locking screw 2 full turns and hitting slightly to break the hold of the taper. Drill two $13/64$ holes at a position such that the steering arm will hit the middle of the stop. Place the required thickness of rubber stops so that the steering handle clears the motor cover sufficiently and safely. This will reduce the angular play of the skis but since the angle was too much at the start, the reduction caused by the stops only brings it back to normal on the Mini Sno.
