Informations techniques/Technical Matters

Industries Bouchard, Inc.

Re: CAPRI 1971

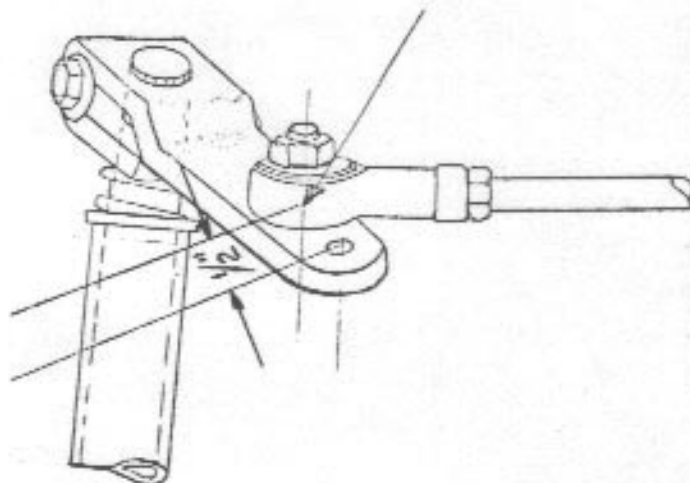
On the 1971 Capri model prior to serial # 1B2J5271, the steering handle bar may stop too close to the windshield trim.

Disconnect the tie rod from the steering arms and drill a 3/8" hole in the steering arms centered at 1/2" forward from the center of the existing hole.

Reconnect the tie rod in this new position.
