Informations techniques / Technical Matters

Industries Bouchard, Inc.

RE: Driven pulley on Zephyr 399cc JLO up to and including 1C4J 17809-17814

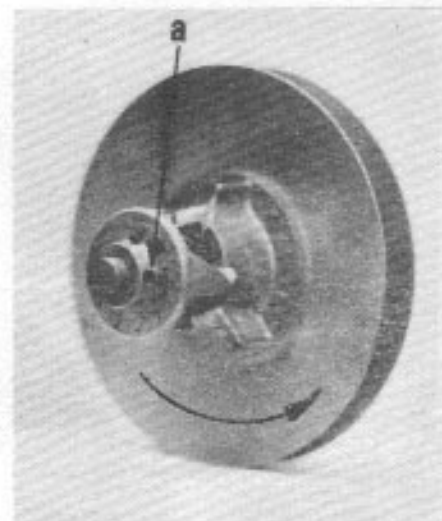
The driven pulley's spring tension was set 1/3 of a turn at the time of production on all units to the above mentioned numbers.

This should be adjusted to 2/3 of a turn at the time of the pre-delivery check. To do so, proceed as follow:

- 1) Drive out the spring pin securing the cam to the pulley shaft. (fig. "A")
- 2) Allow the spring to release back to its normal position.
- 3) Holding the cam from turning, turn the outer half pulley 2/3 of a turn on the shaft. (See arrow on pulley).
- 4) Push the cam inwards to line up the spring hole and reinstall the pin in position.
