Informations techniques / Technical Matters

October 20th, 1971

SUBJECT: CARBURETOR TO MANIFOLD INSTALLATION.

RE: ZEPHYR 340 B.S.E., BETWEEN SERIAL #2C3S9971 & 2C3S10847.

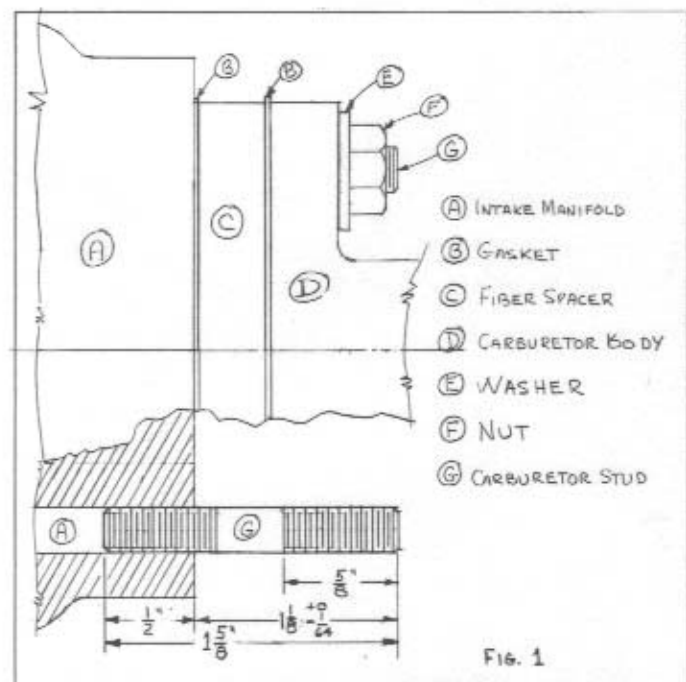
Fig. 1

Carburetor studs (fig. 1, ref. G) threaded into the manifold beyond the given tolerances, leaving insufficient thread to adequately secure the carburetor nut on (ref. F).

The nut could loosen through vibration allowing air to be drawn into the engine and creating a lean fuel air mixture.

Extreme cases could provoke a piston seizure.

Remove the carburetor (ref. D), insulator block (ref. C) and gasket (ref. B); screw out the studs (ref. G) to obtain 1 1/8" of stud exceeding the machine face of the manifold (ref. A).

Reinstall the gaskets, insulator block, carburetor, washers and nuts; tighten adequately.

The ideal installation will show 1 or 2 stud thread exceeding the surface of the nut.

We recommend the use of "Loctite Thread, Locking Sealant" #TL-242 to secure the stud into the manifold.
